Improved Performance of Rock Bolts using Sprayed Polyurea Coating

Eren Komurlu

The University of Queensland School of Civil Engineering & Karadeniz Technical University Mining Engineering Department

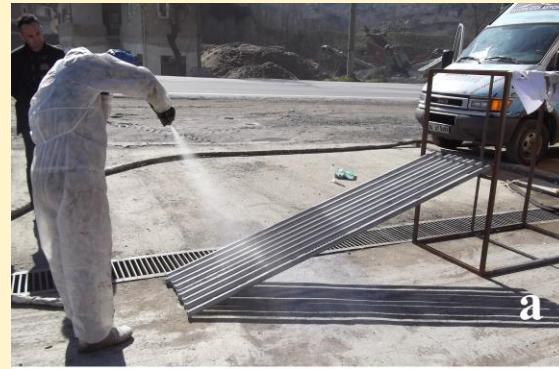
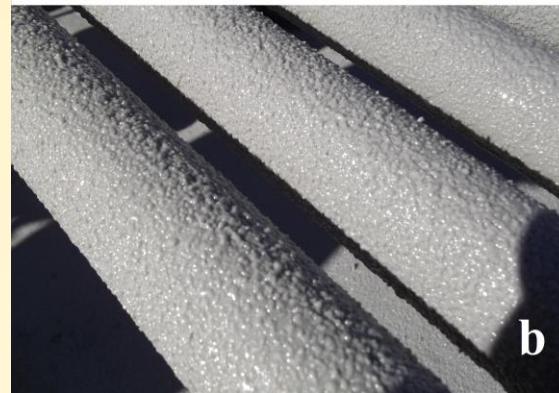
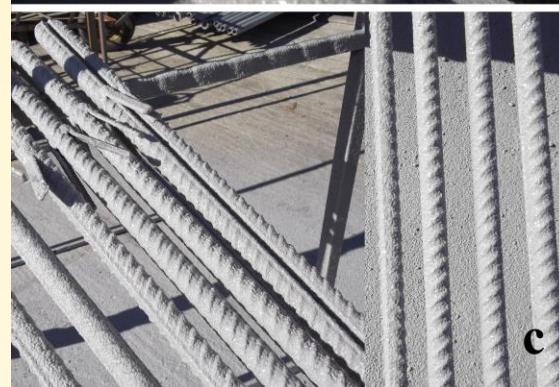
Fig. 1. a) Spray-application of polyurea coating, b) polyurea coated split sets, c) polyurea coated rebars

A field study was performed under acidic underground water conditions at the Cayeli copper mine, which has sulfur-containing minerals. Rebar and split-set type rock bolts applied in the mine were used to test the effect of polyurea coating on load-bearing capacity and corrosion prevention. The steel surfaces of 30 rock bolts (15 rebars and 15 split sets) were treated by polyurea spraying (Fig. 1). A liquid-phase mixture of the polyurea ingredients (isocyanate and amine) was sprayed onto aligned rock bolts that were sometimes rotated to cover all sides uniformly. The rebars and split sets used in the mine are 2.4 m in length. Galvanized steel split sets with a nominal diameter of 39 mm were installed in holes of 36 mm diameter. The rebars have a diameter of 22 mm and non-galvanized ribbed surfaces. As seen in the following figure (c part), the shape of the ribs was maintained when coated with thin polyurea lining.

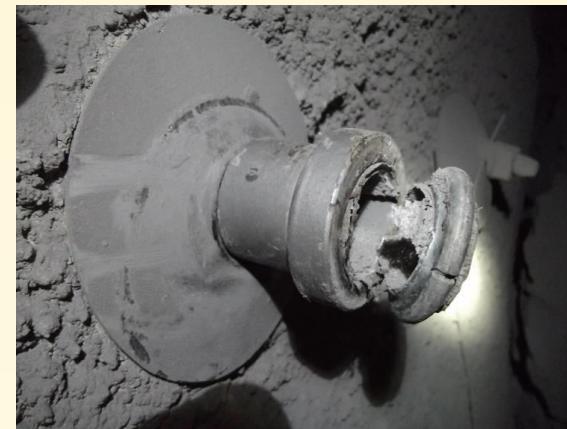
Fig. 2. Example of broken steel of split set with polyurea coating after a completed pull test

A part of the mine with water-related problems was chosen for the installation of the rock bolt specimens. Pull-out tests were separately performed on coated and uncoated rock bolts to examine the effects of the surface treatment after one week, five weeks, and six months from installation (Table 1). The load-bearing capacity of the uncoated split sets was excessively reduced by corrosion. On the other hand, there was no adhesive failing between the PCRB (polymer coated rock bolt) and the hole surfaces. As shown in Fig. 2, the steel of the polymer-coated split sets broke at the end of pull-out test.
